DEPARTMENT OF NATURAL RESOURCES
DIVISION OF OIL, GAS AND MINING

RE: Site Inspection, Lexco, Inc.; ITM Mine, S/047/035; Uintah County; Utah

Date of Inspection: May 23, 2003
Time of Inspection: About 4:15 to 4:40 p.m.
Conditions: Mostly clear, 80's
Participants: Paul Baker (DOGM)

S/047/035, ITM Mine, Lexco, Inc.

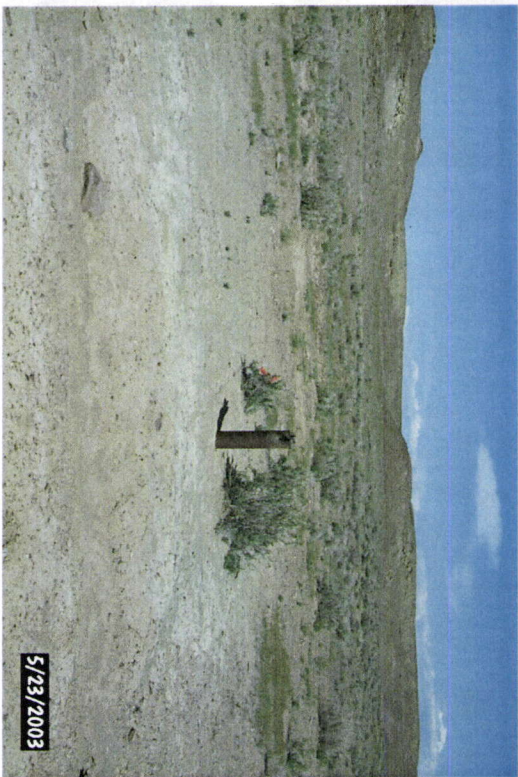
The first hundred yards or so of the road was not reclaimed. There is a monitoring well at the end of this section of road (Photo 1).

The portion of the road that was not reclaimed appears to have been built for access to the well, and it was there before the mine was built according to the operator, Jim Lekas. He reclaimed the portion of the road that was built for the mine. I felt the grading was done well and that the disturbed areas blend with surrounding areas.

Photo 1. This is a monitoring well at the end of the unreclaimed section of road.

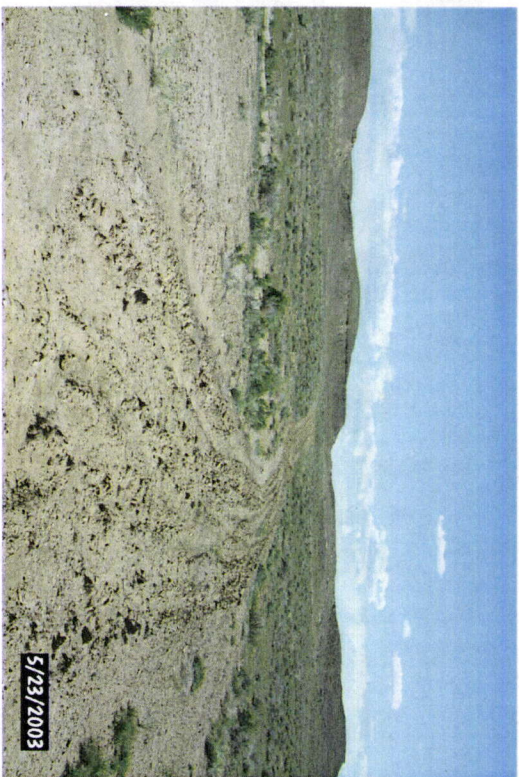
The road appears to have been ripped and seeded (Photo 2), and there were some seedlings growing (Photo 3). It is impossible to tell at this time how successful revegetation will be.

Photo 2. The reclaimed road.

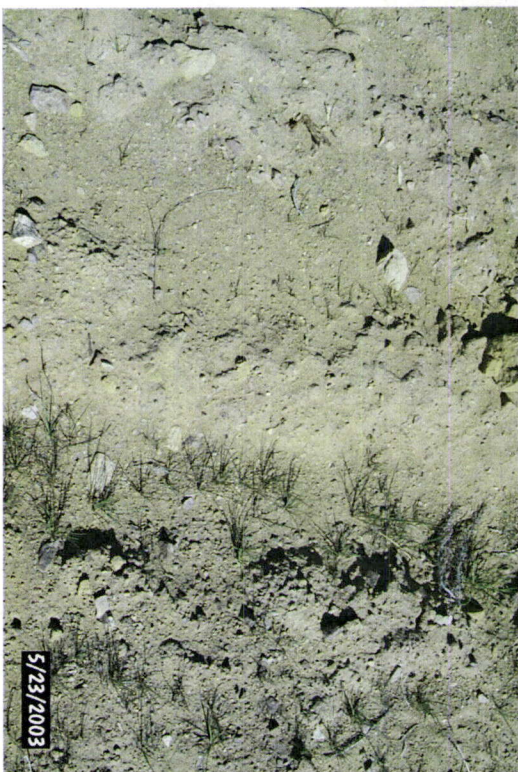
Photo 3. Seedlings growing in rips in the road.

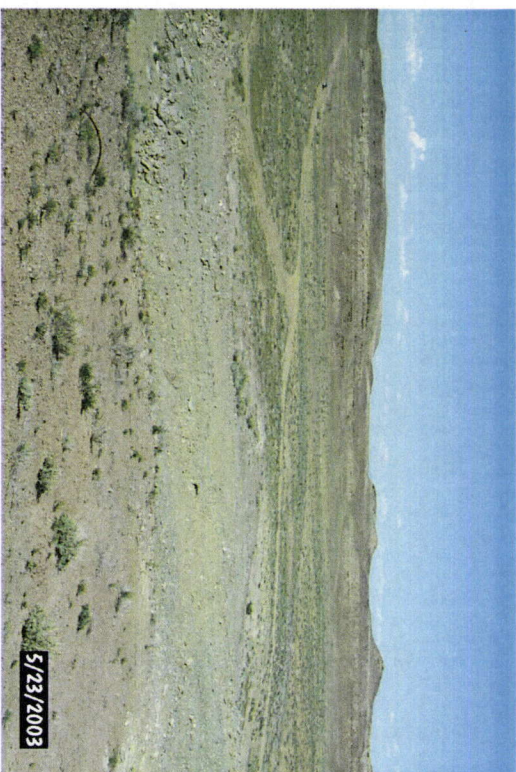
Photo 4 shows the mine area and, in the distance, the road. I am not familiar with the history of this site and whether any topsoil was salvaged, but it did not appear soil was spread over most of the mine area. Possibly because of this, I saw very few seedlings in this area.

Photo 4. The center of this photo shows the mine site, and one can see the reclaimed road in the distance.

The operator and the Division will want to monitor vegetation as it grows. Although I have some doubts about how much vegetation will become established in the mine area, I do not yet recommend remedial action.
